Report: HMC-C200 stability problems

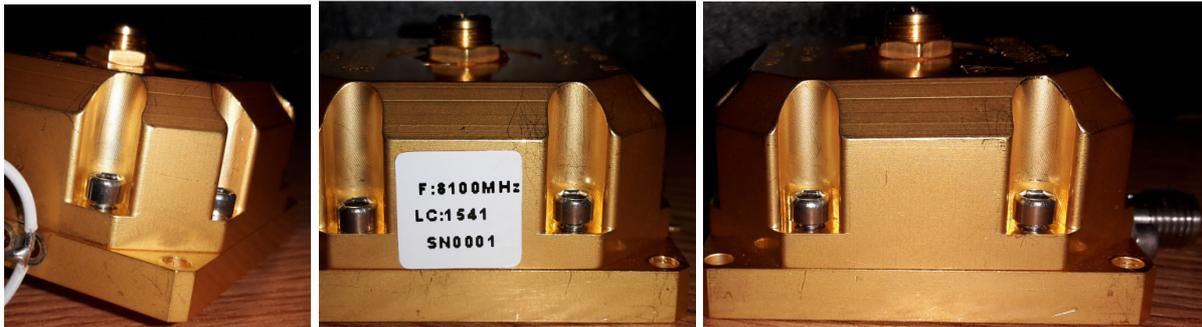
It was observed that, when received, some of the screws on the two 8.1 GHz modules were not fully fastened. The modules also showed some scratch marks.

Screws not properly fastened when received - SN 1541-0002 on the left, SN 1541-0001 centre and right

The modules were initially tested without adjusting the screws, but later they were fastened. It did not make a difference to the results.

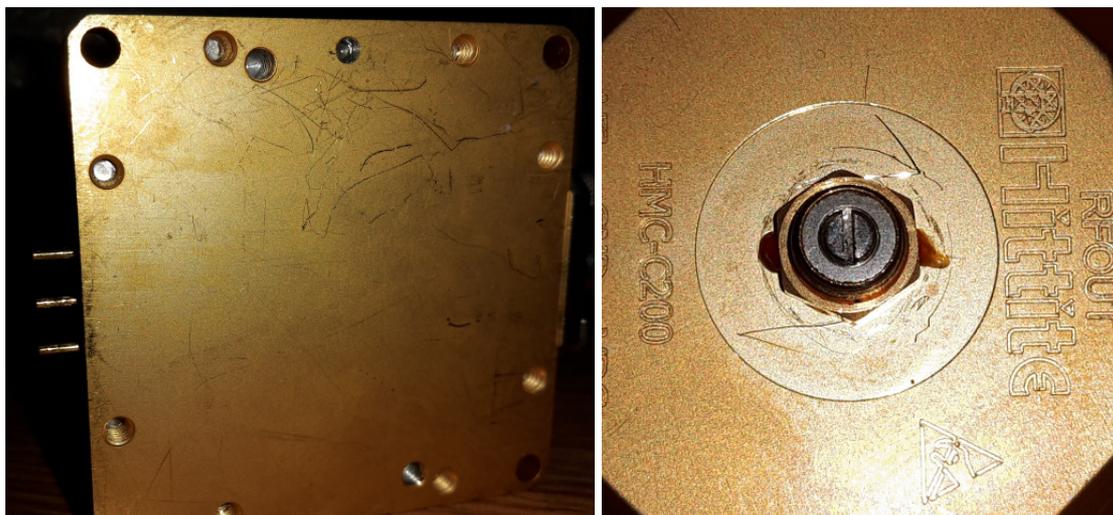
Scratch marks visible on SN 1541-0001 when taken out of the box.

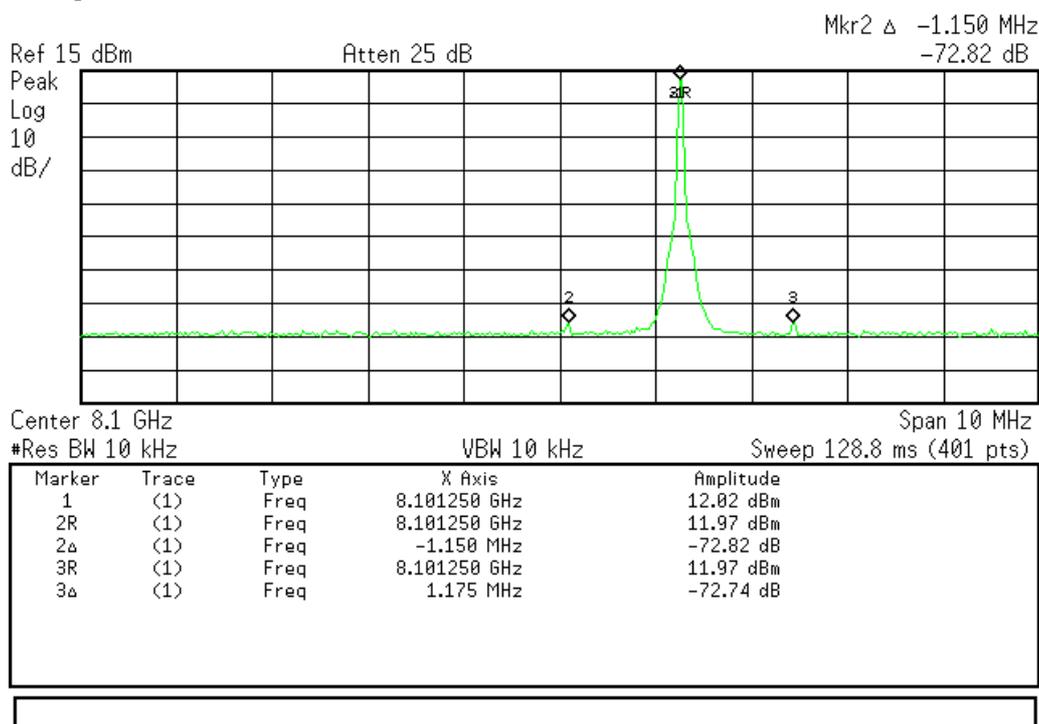
The 8.1 GHz unit was measured on the spectrum analyser and it was found that the max output power was achieved with a VT of 6.5V. Some spurs were observed close to the carrier (see figure below). Harmonics were measured to be -24.9 dBm (higher than specified) and -35.0 dBm for second and third harmonics respectively. The power meter confirmed the output power level to be 13.5 dBm.

Output power spectrum showing close-in spurs

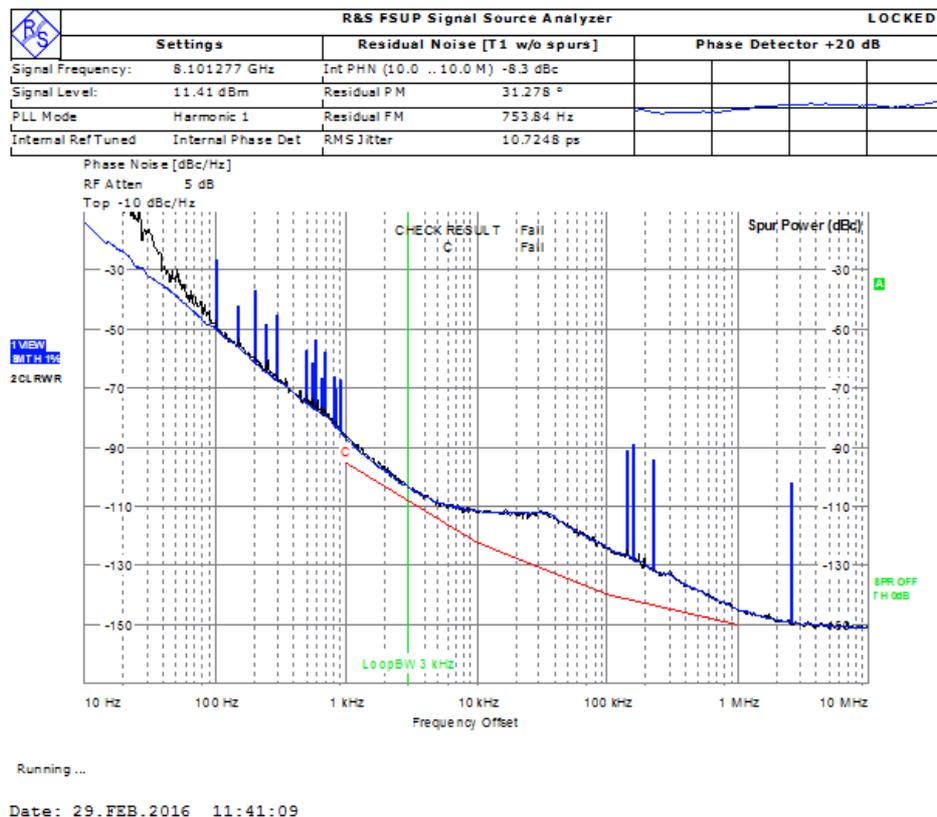
The test setup was extremely sensitive to any disturbance or movement. It was easily demonstrated that touching the RF cable between the DRO and signal analyser caused a disturbance in the output signal. Touching the DRO casing caused a shift in frequency. Waving one's hand close to the DC pins caused disturbances in the phase noise. These responses are hard to quantify or capture in a photo, but they were *not* subtle. In the screen shot below, a disturbance can be seen in the low-frequency phase noise (black trace) and the detector trace (top right of the image). This disturbance was caused by waving a hand close to the unit, and is *very small* compared to other disturbances witnessed.

Is it possible that there is RF leakage present outside the unit, which couples back into the module and which can be easily disturbed in the ways described above?

Measured phase noise of 8.1 GHz module (SN 1541-0002), with 100nF decoupling capacitor on VT pin, VDC = 6.4V, VT = 6.5V. A hand is moving close to the DC pins, causing a disturbance.

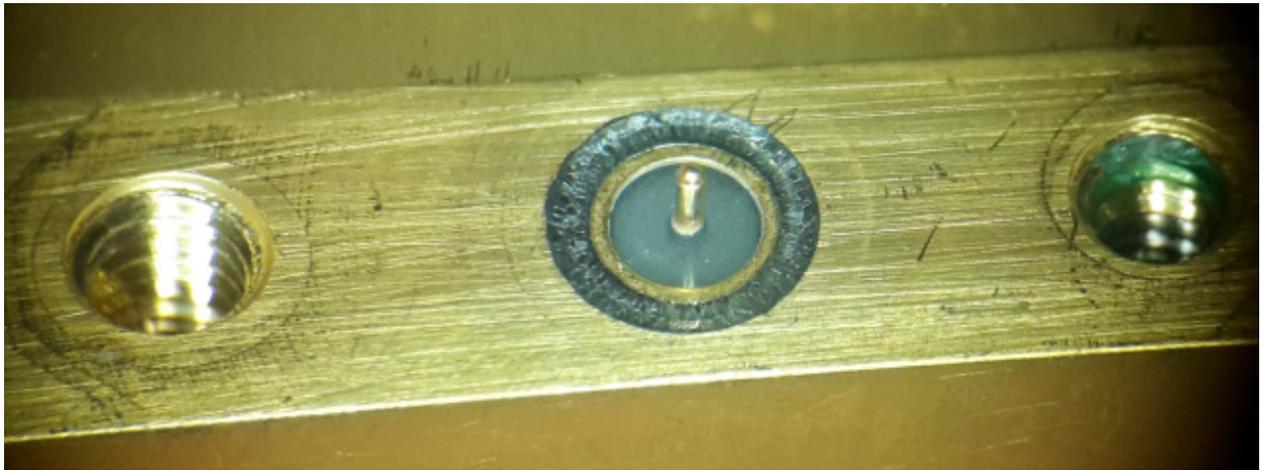
The field-replaceable SMA connector of one of the modules was removed. It was observed that the ground ring of the coaxial transition is not positioned flush with the surface of the module (see picture below). Instead, it is slightly recessed. This will cause an air gap between the ground surface of the field-replaceable SMA connector and the ground ring on the DRO module, when they are mated. This is a cause of concern and possibly the reason that the RF signal is leaking out of the module.

It is also unusual that the GND pin is not grounded directly on the chassis where the pin enters the body, but instead leads to a feedthrough component. Does this not create a path for disturbances on the line to enter the cavity?

RF pin on DRO module, with SMA connector removed

Experiments using shim to provide a more continuous ground ring did lead to an improvement in the sensitivity.
