Failure Analysis Report 241314

Customer: SHANGHAI HENTE ELECTRONIC TECH
 ADI Part Number: ADSP-21571CSWZ-4
 Report Date: 13-Dec-2022

Failure Analysis Conclusions

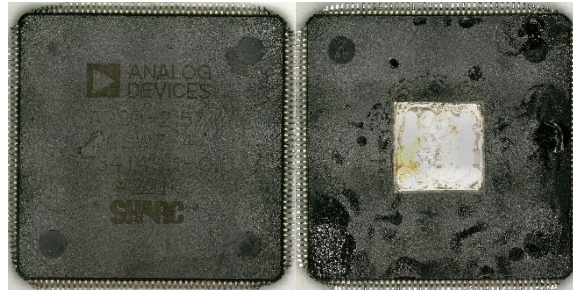
The external condition of the unit was inspected using a stereo microscope. No anomaly found.

Figure 1: Images showing the units as it was received for analysis.

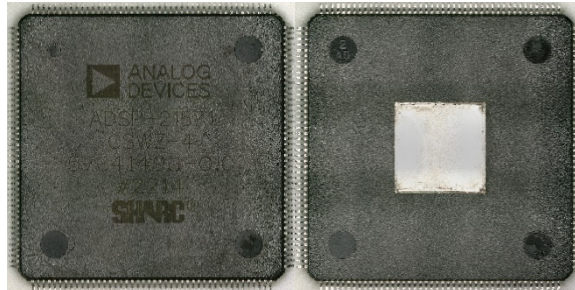
The external condition of the unit was reinspected using a stereo microscope.

Figure 3: Post reconditioned images
