ADV7619 / ADV511 Advantiv Video Evaluation Board

Title	PAVPipe Power	
Size	Document Number	Rev 1
C	<Doc>	
Date:	Tuesday, April 05, 2011	Sheet 3 of 11

Title	PAVPipe ADV7619	
Size	Document Number	Rev
C	<Doc>	1
Date:	Friday, August 05, 2011	Sheet 6 of 11

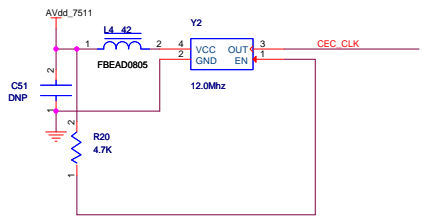
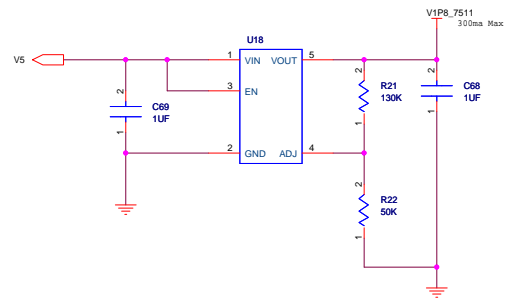
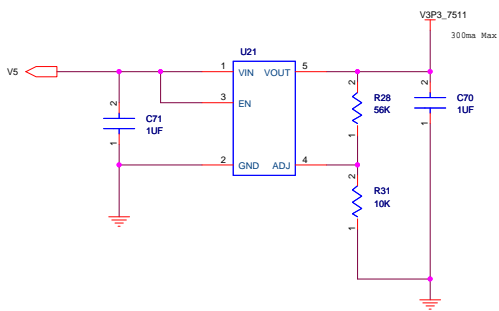
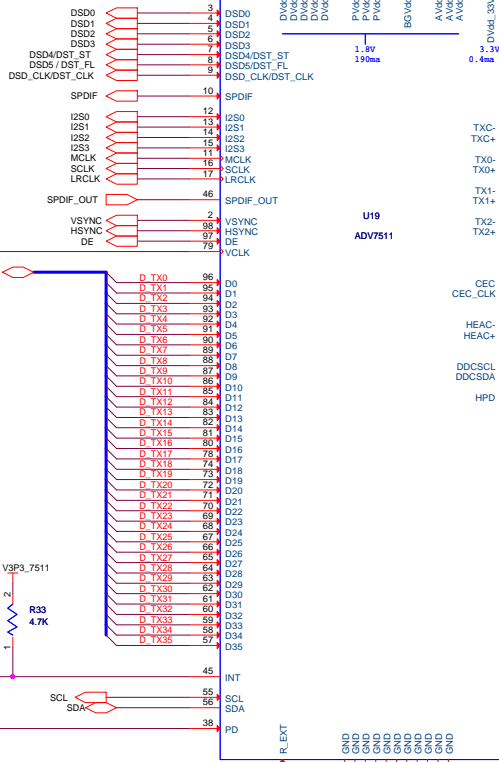
Bypass caps should be near their respective power pins
