Report: HMC-C200 stability problems

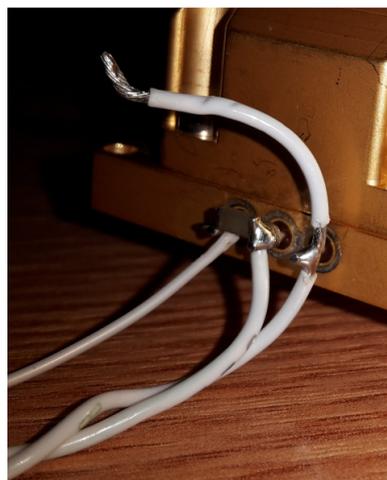
DC voltage connections

Initially, VT and VDC were connected together, and a 100nF capacitor was soldered between the GND and VT pins. Later, these two voltages were driven separately. The picture below shows the capacitor, and the separate wires. The loose wire standing up is the previously used connection between VT and VDC.

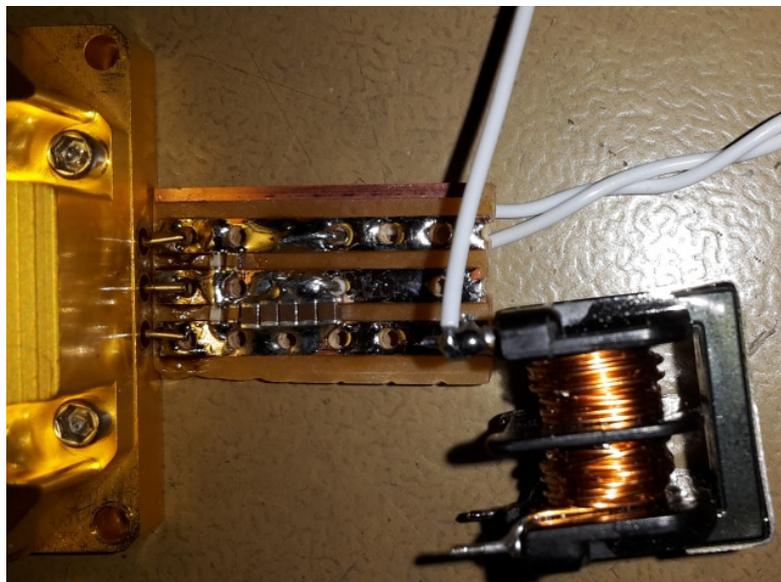
Decoupling PCB soldered to DRO pins

Finally, a small PCB was built to implement the decoupling capacitors and inductors as suggested in the datasheet, using available components. This small PCB was soldered directly to the three pins of the DRO.
