Advantiv (TM) EVAL-ADV7842-7511 Video Evaluation Board

| Title | | PAVPipe Block Diagram | |

| Title | | PAVPipe Power | |

| Title | PAVPipe | Video Input Connectors |

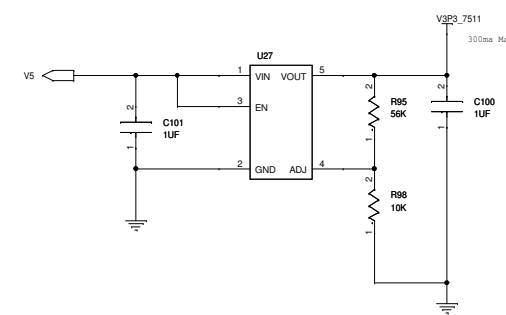
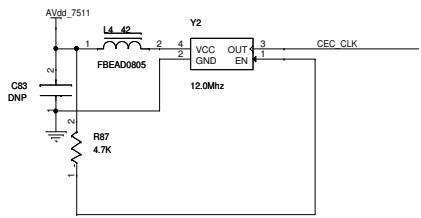
Place as close to pin on bottom of PCB and far from LRCLK, SCLK, or WCLK

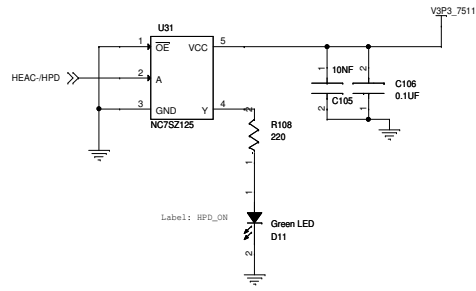
100 Ohm impedance differential tracks
 HEAC+ <<
 HEAC-HPD <<
